# **Wiley Fox Swift Service Manual**

## 1. A5042 (WILEY FOX SWIFT) overview

### 1.1 A5042 (WILEY FOX SWIFT) brief introduction

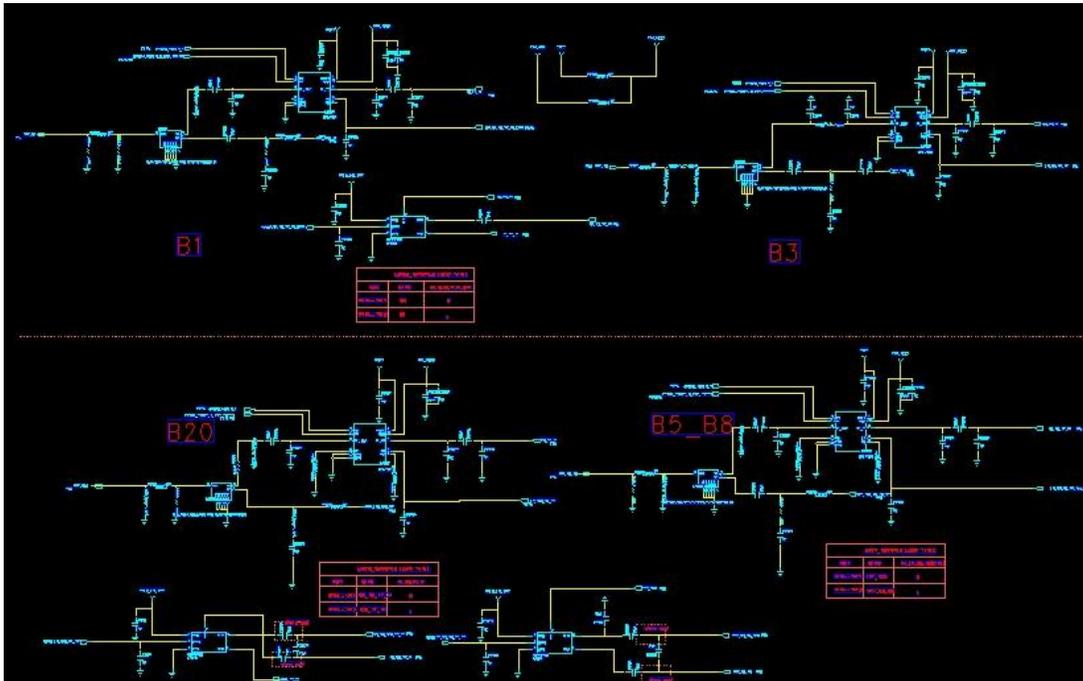
LTE: (B1) / B3 / B20 and WCDMA: B1 / B8 (or B5) section:

Emitting section: baseband signal WTR4905L after internal conversion and amplification, LTE B1 and B3 from WTR4905L port TX\_DA1 (B1\_B3\_TX\_IN) output via two routes through the switch U3505 corresponding match to B3 PA U3502 and B1 PA U3504, PA signal amplification then, respectively, after each diplexer (B1: U3501, B3: U3503) to PA U3103 by matching an internal switch to the antenna. LTE B20 and WCDMA B8 (or B5) by the WTR4905L port TX\_DA2 (B5\_B8\_B20\_TX\_IN) output via two routes through the switch U3510 corresponding match to B20 PA U3507 and WCDMA B8 (or B5) PA U3509, PA signal is then amplified by a match After each diplexer (B20: U3506, B8 or B5: U3508) U3511 merge the two routes to the switch all the way to PA U3103 internal switch to antenna. Signal external power coupler U3101 detected through pin6 output to WTR4905L the PIN 31, it is used to power detection and control.

Receiving part: receive a signal from ANT U3101 through the coupler to the PA U3103, after the PA U3103 internal switch in three columns, two-way through each BAND corresponding DUPLEX (B1: U3501, B3: U3503) to the common terminal RX crossover , and then were to WTR4905L of PIN10 (PRX\_MB2) / PIN5 (PRX\_MB3) by the internal LNA amplifies, downconverted to a baseband signal; another way to switch U3511 after then were two routes into the respective DUPLEX (B20: U3506, B5 or B8 : U3503) common terminal divider to RX, then were to WTR4905L of PIN17 (PRX\_LB1) / PIN11 (PRX\_LB2) by the internal LNA amplification, downconversion to baseband signals.

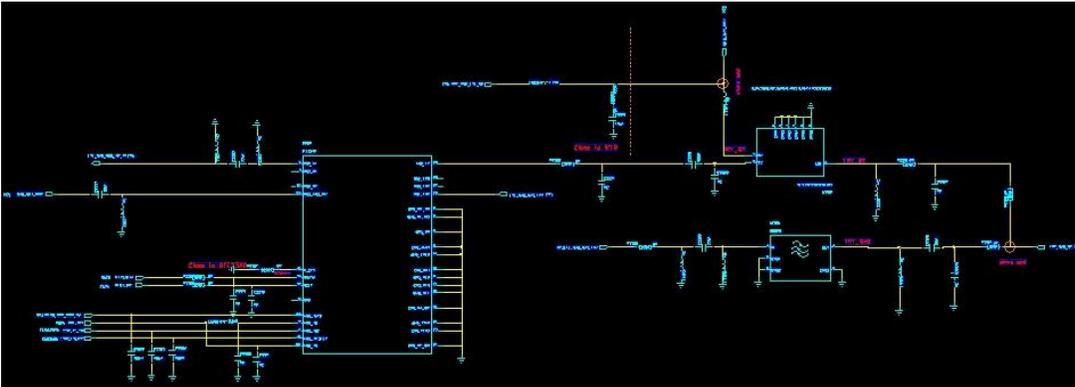
### LTE B7 section:

The baseband signal WTR4905L after internal conversion and amplification from TX\_DA3 (LTE\_B40\_B38\_B7\_IN) output, after output matching to the PA U3301. After the PA signal amplification output from pin29 (HB1\_TX) to duplexer U3302, and then output to the PA U3103 through its internal switch to the antenna. Signal external power coupler U3101 detected through pin6 output to WTR4905L the PIN 31, it is used to power detection and control. It receives signals from the ANT through PA U3103 through its internal switch to the duplexer common U3302 to RX, and then to WTR4905L the PIN 22 (PRX\_HB2) by the internal LNA amplification, downconversion to baseband signals.

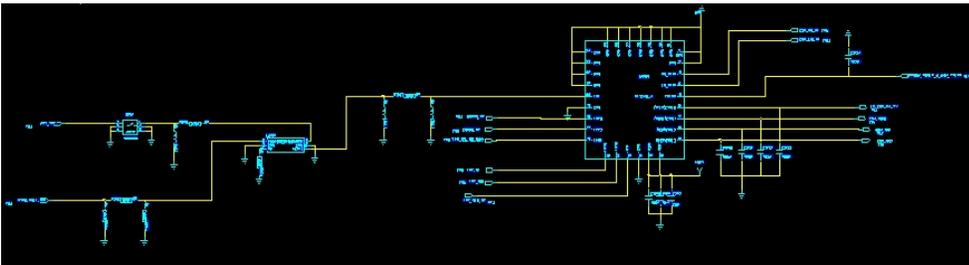
### GSM part of the work Circuit:

The baseband signal WTR4905L after internal conversion and amplification from TX\_DA4 (GSM\_LB\_IN) / TX\_DA5 (GSM\_HB\_IN) output, to the PA U3103, PA amplified output signal to the antenna terminals. PA U3103 receives signals from the internal antenna after switching to match the corresponding SAWLESS WTR4905L, downconverted to a baseband signal.

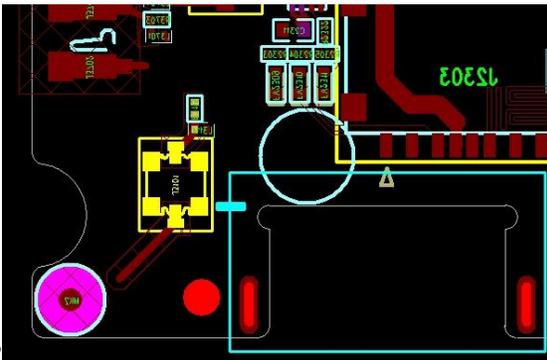
1. Visual inspection of RF test socket is welded J3101 good? Female polarity is correct? Female center for foreign

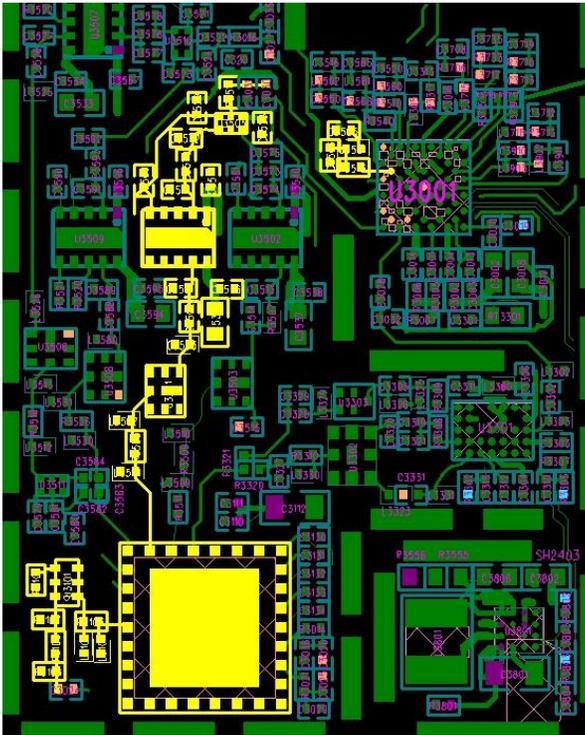
(1) LTE B1 or WCDMA B1 section:

Problems for the band as a test circuit is highlighted (as the figures yellow)

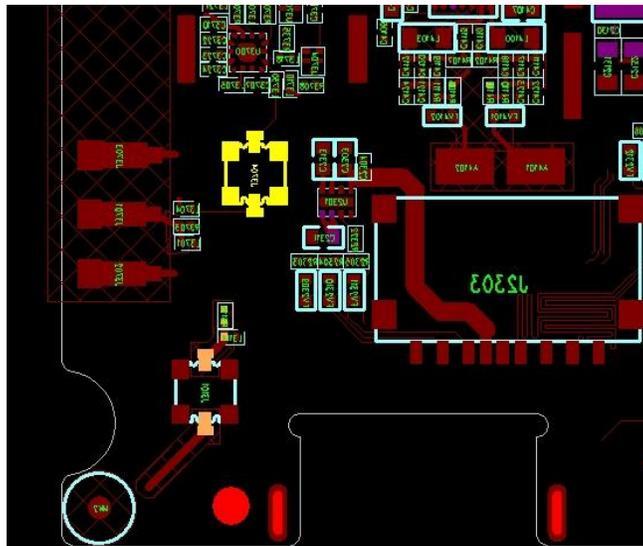
1. Visual inspection of RF test socket welding J3704 good? Female polarity is correct? Female center for foreign objects?

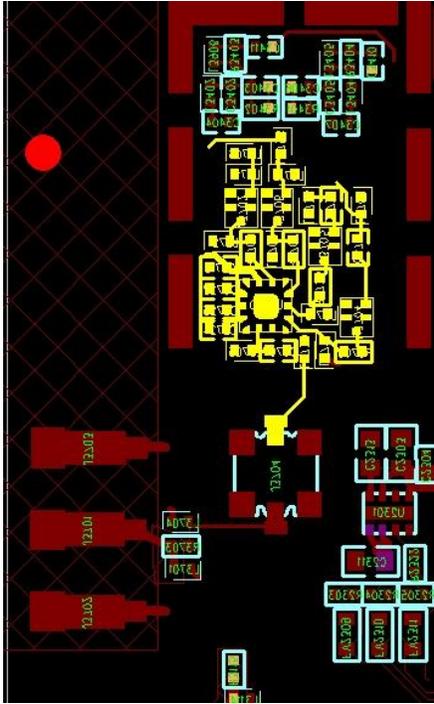
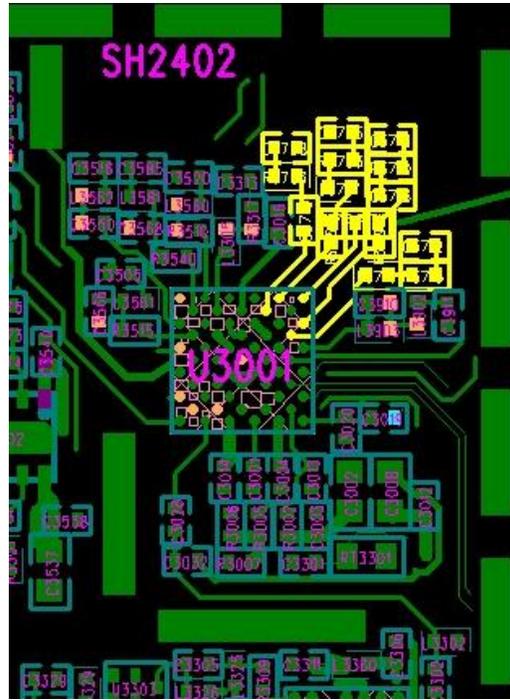
☒2, matching circuit elements on the receive path if the patch abnormalities, such as visual inspection are no exception, replace the test

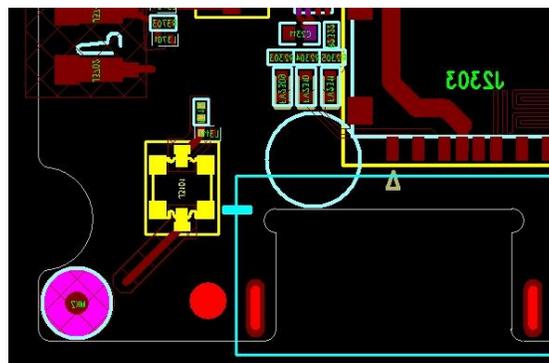
Visual inspection of RF test socket is welded J3101 good? Female polarity is correct? Female center for foreign objects?

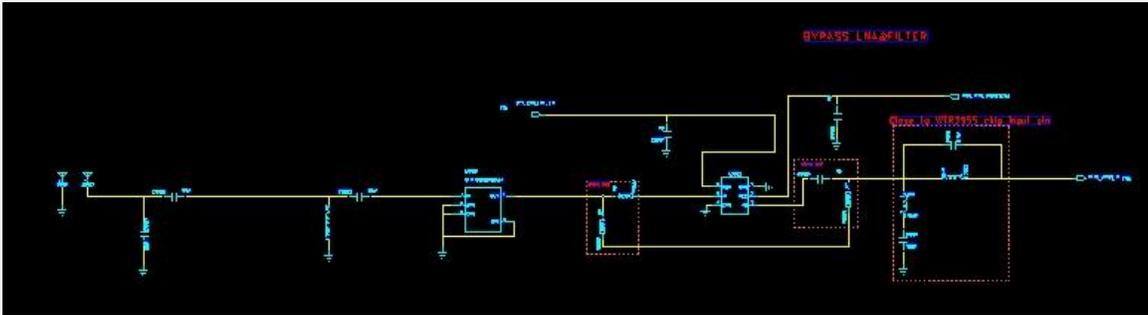
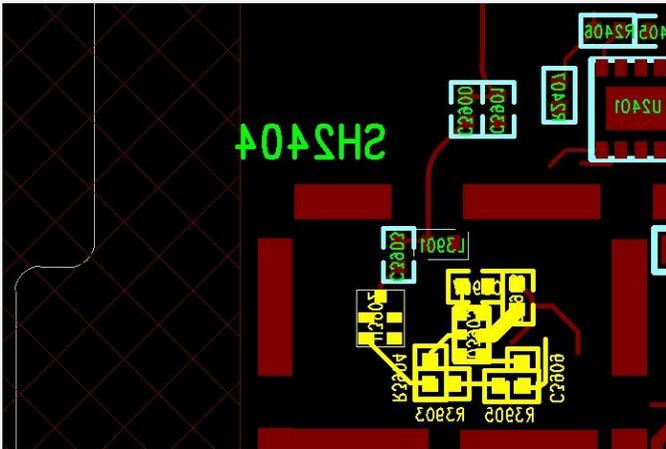
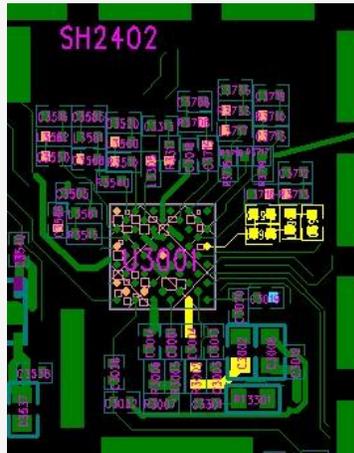
GPS signal first enters the GPS filter U3902, filtered through amplification U3903, U3001 inputted to the chip, the demodulated signal.

GPS satellite can not be searched or satellite search CN value is low, check the U3902 filters and peripheral circuits are weld, and then check whether U3903 LNA working properly, as they pin PIN2 voltage 2.05V power supply is normal, the pin is enabled PIN5 open, if normal, may not posted U3001 good or damaged.

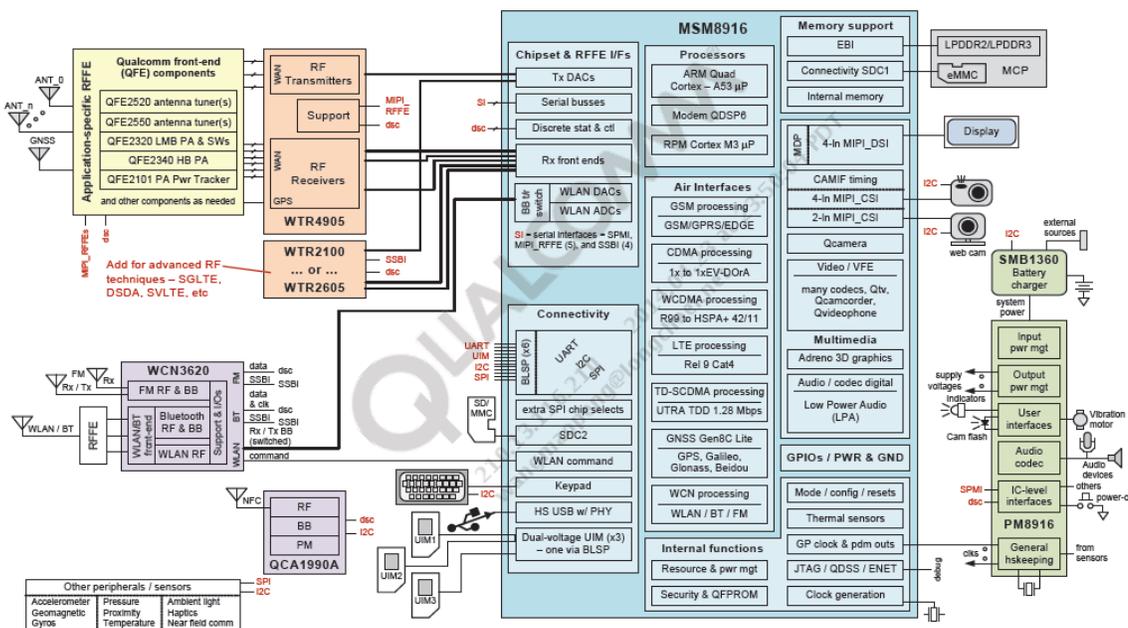
Figure 1-1 MSM8916 functional block diagram and example application

Baseband circuit completes main functions: the procedure data storage, keyboard input, and the communication between the RF module, RF power control, the control of the power management module, RUIIM card interface, serial download interface, Camera, T-flash, Bluetooth, and MMI (man-machine interface, such as the display, backlight, buzzer, speaker, microphone, motors, etc.). Baseband section has very regular modules, and corresponds to the following function. The functions of each module are summarized below.

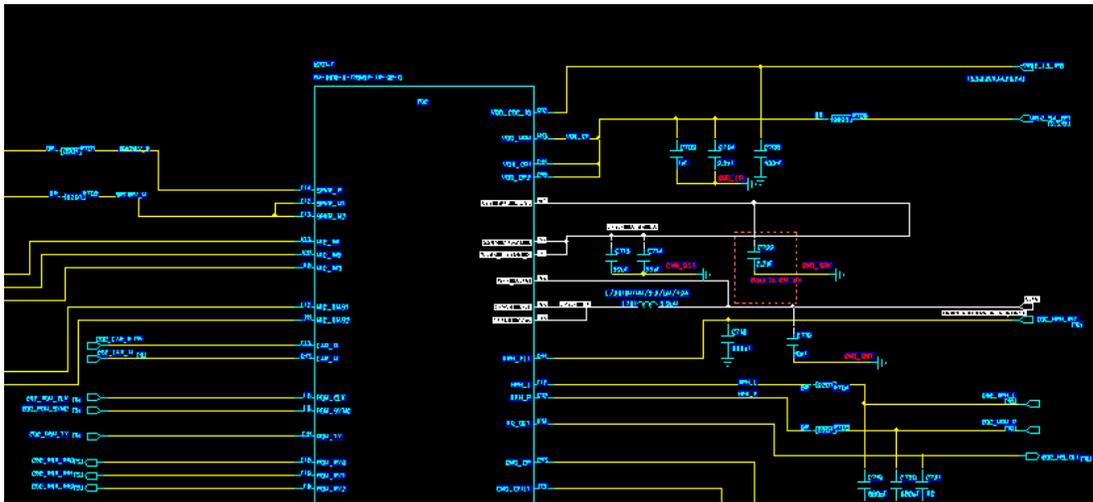
The A5042 (WILEY FOX SWIFT) phone's speaker circuit is as follow, PMIC to the speaker directly

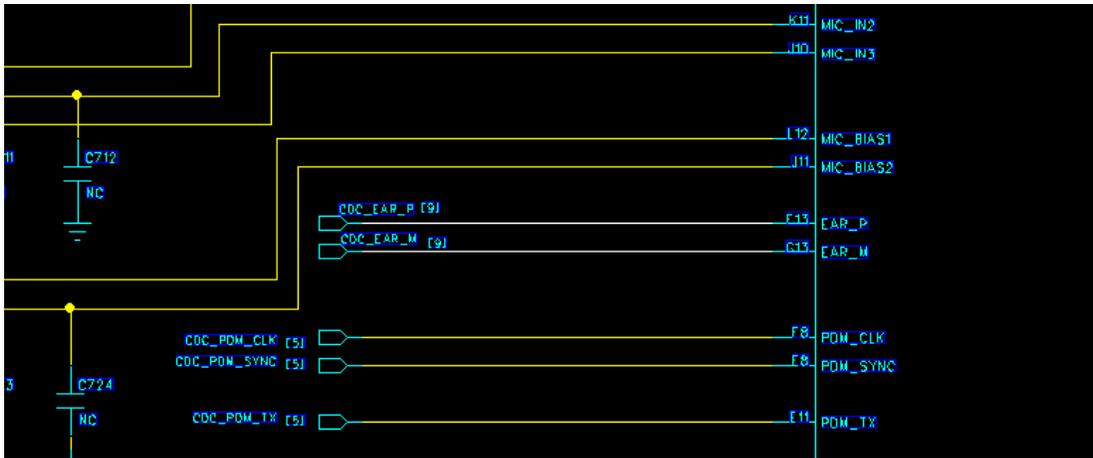
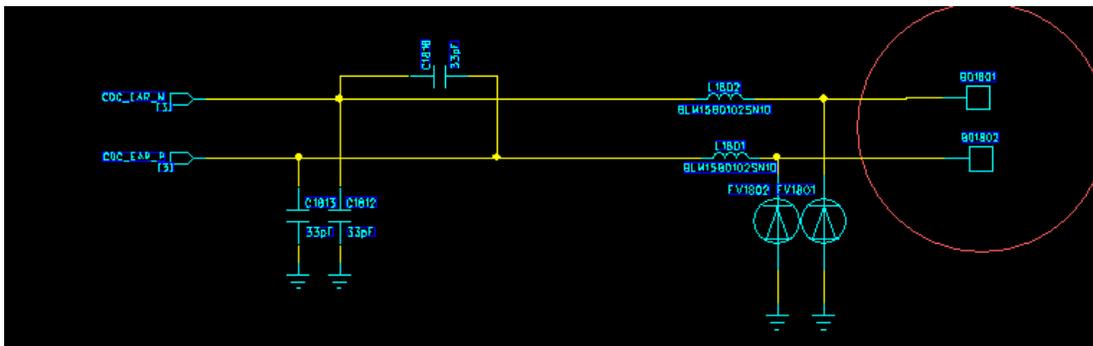
**Receive Loop**

A5042 (WILEY FOX SWIFT) phone receiver is embedded in the mobile phone front shell through shrapnel and motherboard connection. Mainly used for the call. Receiver circuit diagram as shown below.

1, Receiver without sound: 1) Receiver assembly adverse, the shrapnel and board poor contact 2) Receive ontology bad 3) the volume settings or software problems

2, Receiver noise or volume: 1) Receiver incoming material, whether caused by pad short circuit 2) relevant components have solder skips 3) software problems

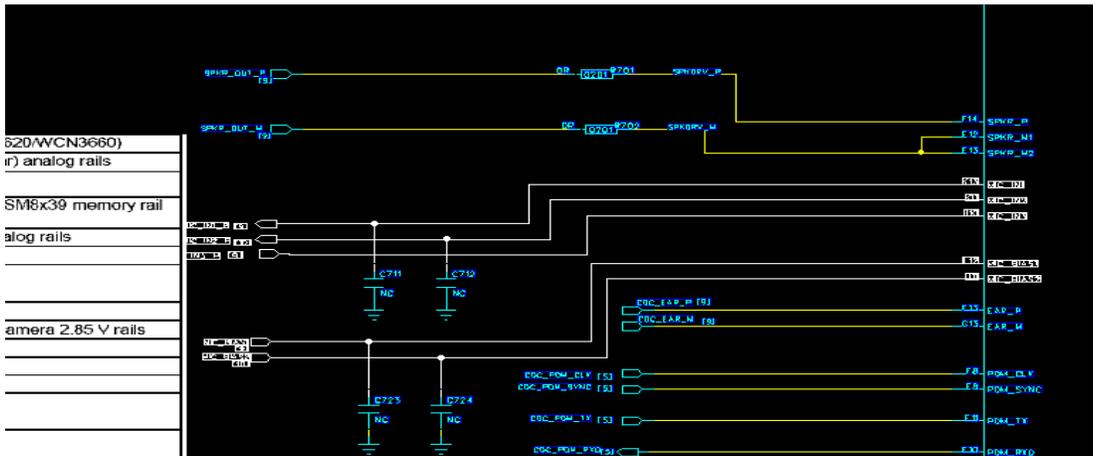
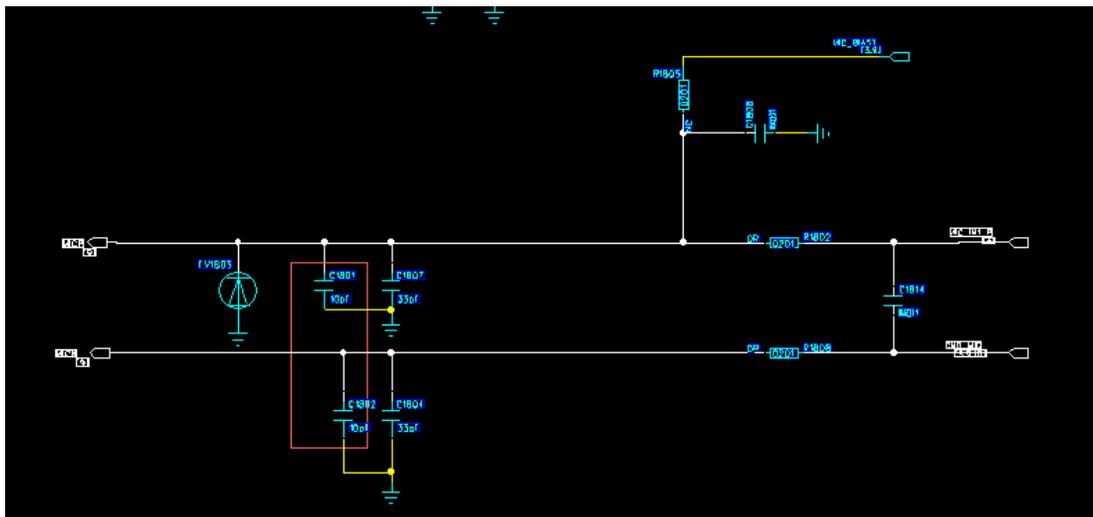
MIC 1 (in SB)

The A5042 (WILEY FOX SWIFT) contains two electret condenser MIC circuits for reduce noise except headphone MIC. One in MB M1801 for reducing noise. Loop schematic diagram as following:

- 1 MIC unable to send words or recording: 1) MIC poor welding 2) MIC body bad
- 2 MIC noise or sound: 1) MIC ontology bad 2) software problems.

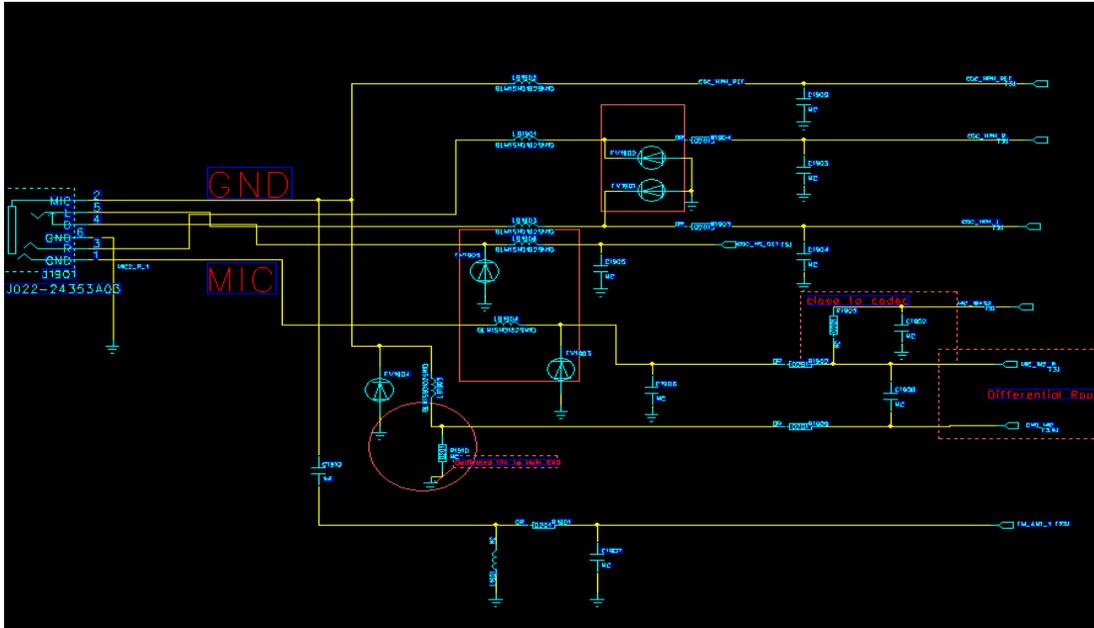
3.5mmHeadphone jack circuit

A5042 (WILEY FOX SWIFT) phone use headphones with a standard 3.5mm headphone. Its circuit diagram is as follows:

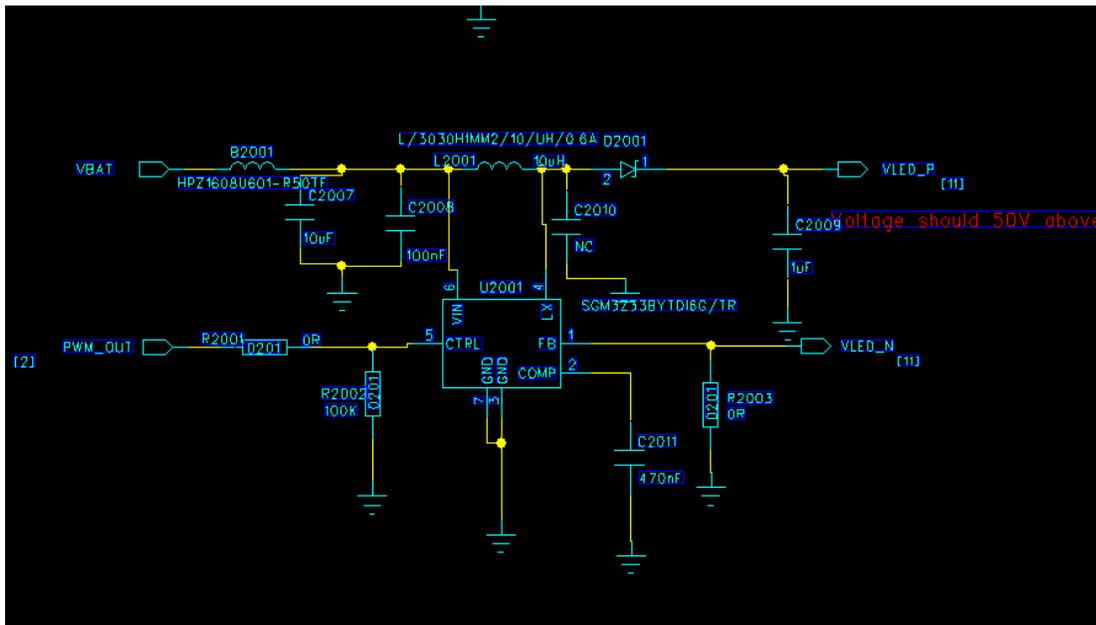
LED DRIVER IC

A5042 (WILEY FOX SWIFT) adopts 5 -inch LCD, The part of the circuit schematic as shown below. Common problems and causes of the LCD module:

- 1, LCD screen is blank. 1) LCD is not installed or and fixture poor contact) LCD backlight circuit is bad, check backlight so that the foot is pulled, check whether the R2003 welding problems, backlight IC U2001 whether Weld or shorted to ground. 3) LCD itself fault.

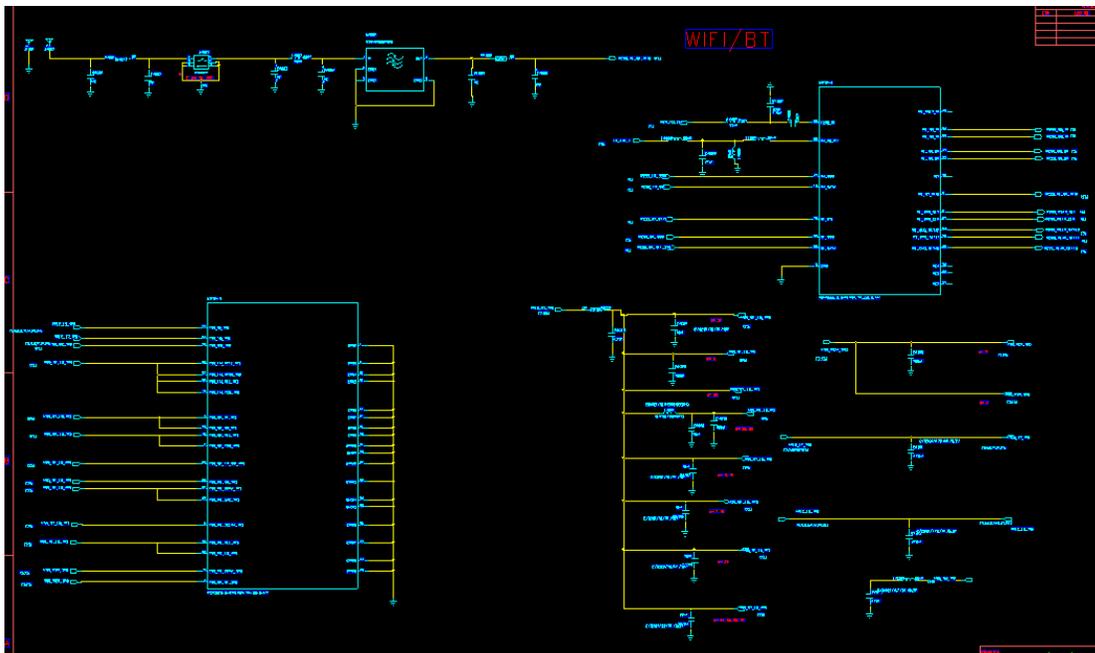
A5042 (WILEY FOX SWIFT) BT adopts WCN3620 chip. Data transfer interface and audio interface are directly connected to the CPU. Common failures are:

2, Bluetooth effective distance is short, easily disconnected. Need to check whether Bluetooth antenna circuit soldered or short circuit, Bluetooth antenna and motherboard contact well.

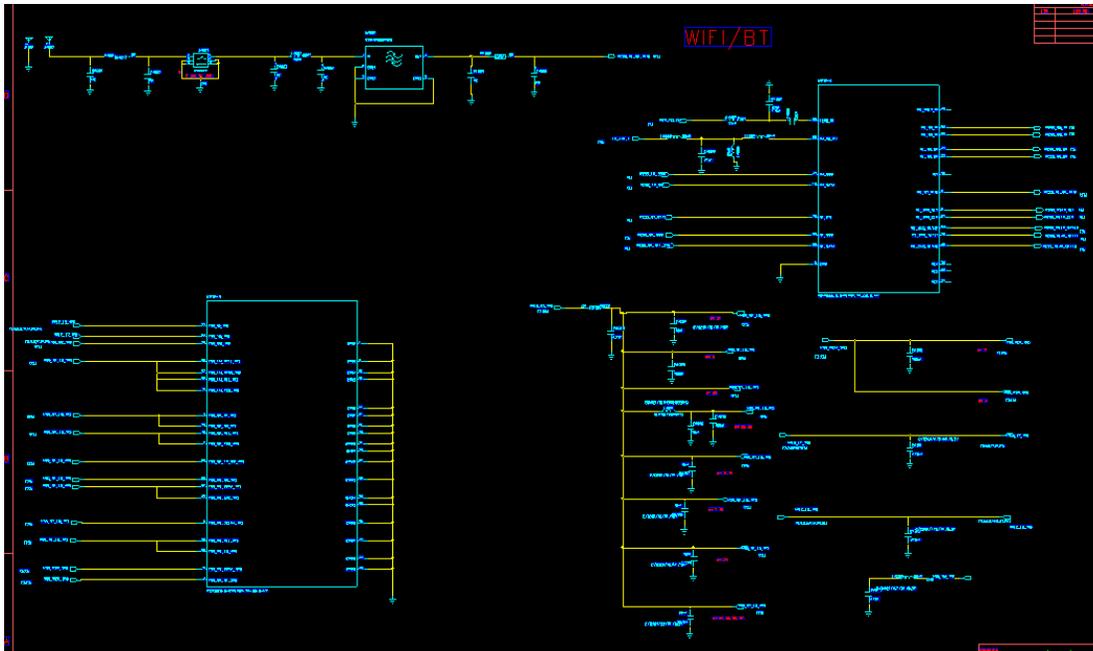
WIFI function failure, you need to check the WIFI is turned on, WIFI visibility settings are correct. WIFI power supply and clock circuit whether there is a short circuit or Weld phenomenon.

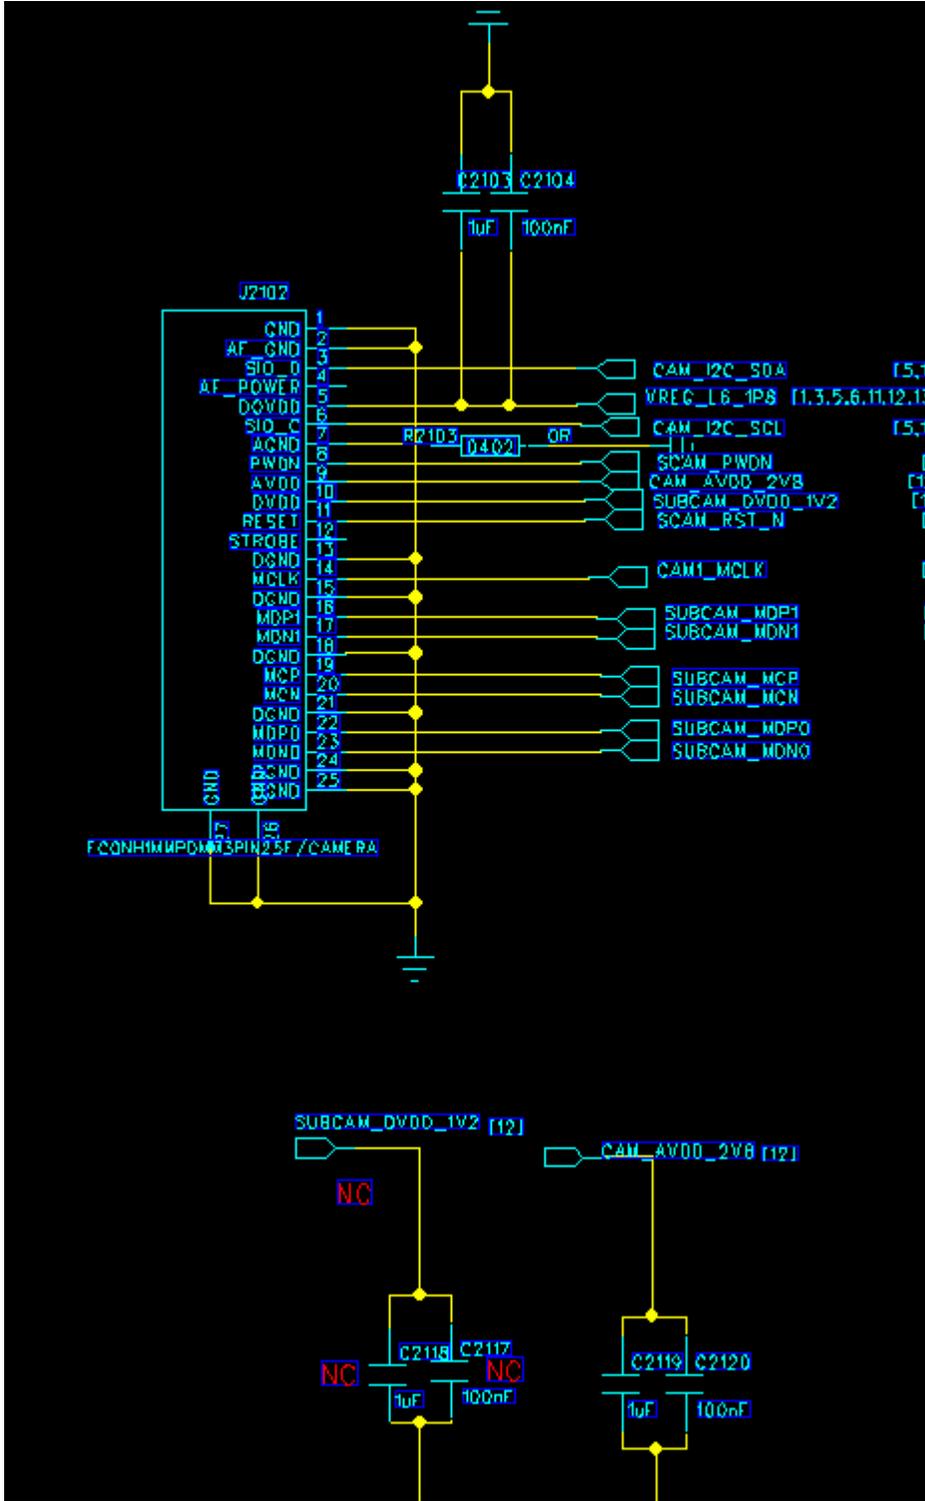
SUB Camera

Connect with the CPU through a dedicated Camera IF port. Camera control is done through the I2C bus. Camera common fault and why:

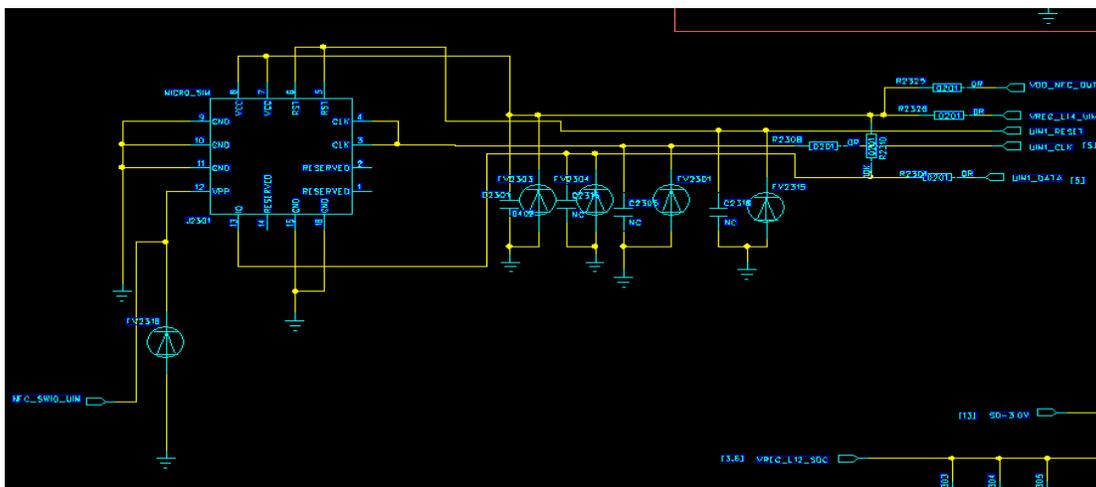
USIM card circuit

A5042 (WILEY FOX SWIFT) USIM card module circuit is connected directly with SOC and PMIC through eight-path signal from SUIM slot. The major failure of the module does not know the card, the reason usually: 1) USIM card GSM card and USIM deck poor contact 2) poor USIM card socket welding 3) software problem cause the phone to pick a card, change the card to confirm. 4) USIM card holder exist Weld; 5) card exceeds the itinerary or inserted upside.

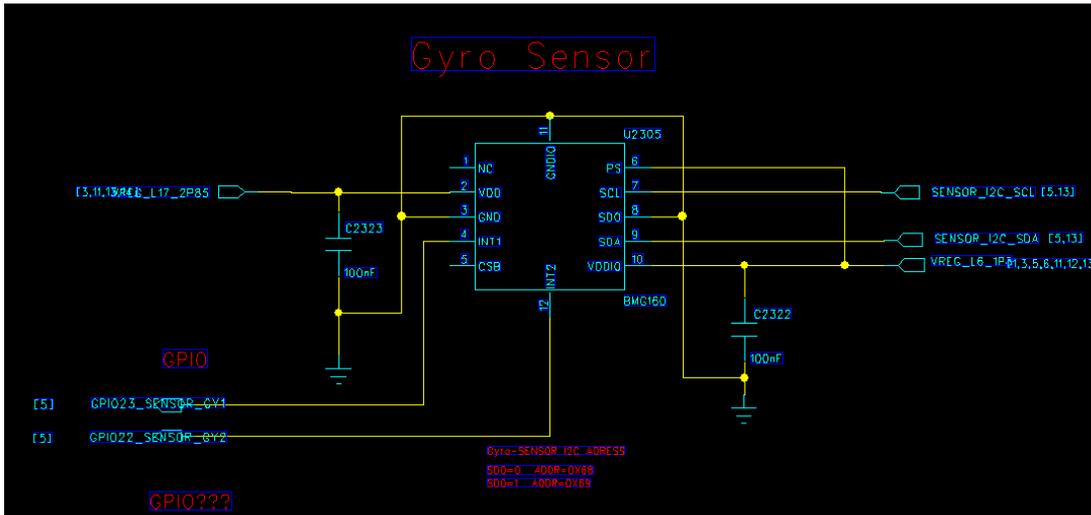
Gyroscope circuit

A5042 (WILEY FOX SWIFT) Gyroscope Sensor circuit is connected with CPU through the special I2C, circuit diagram shown below.

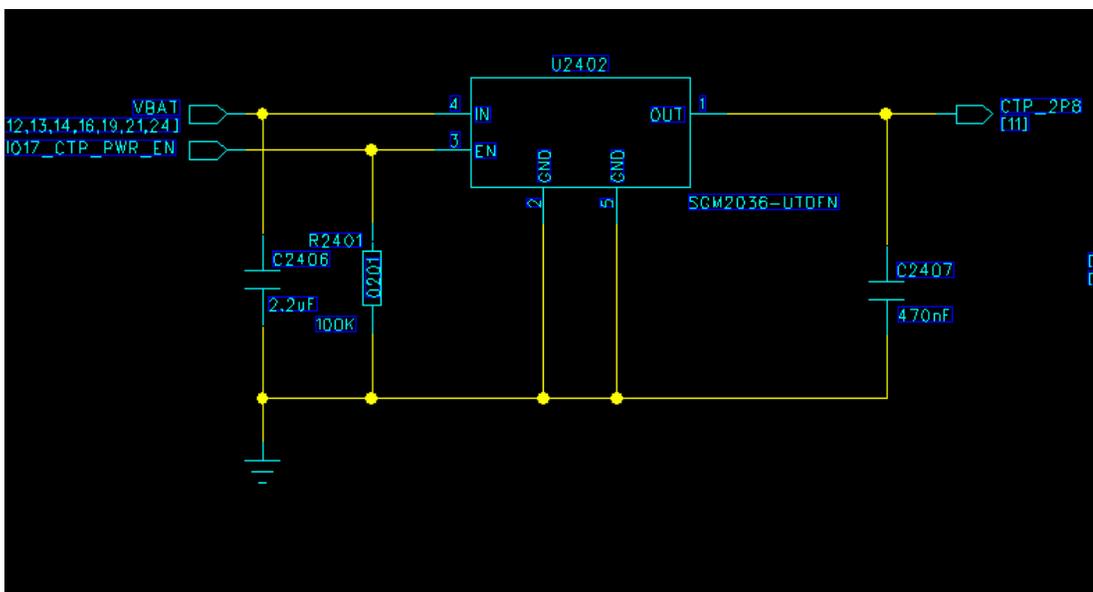
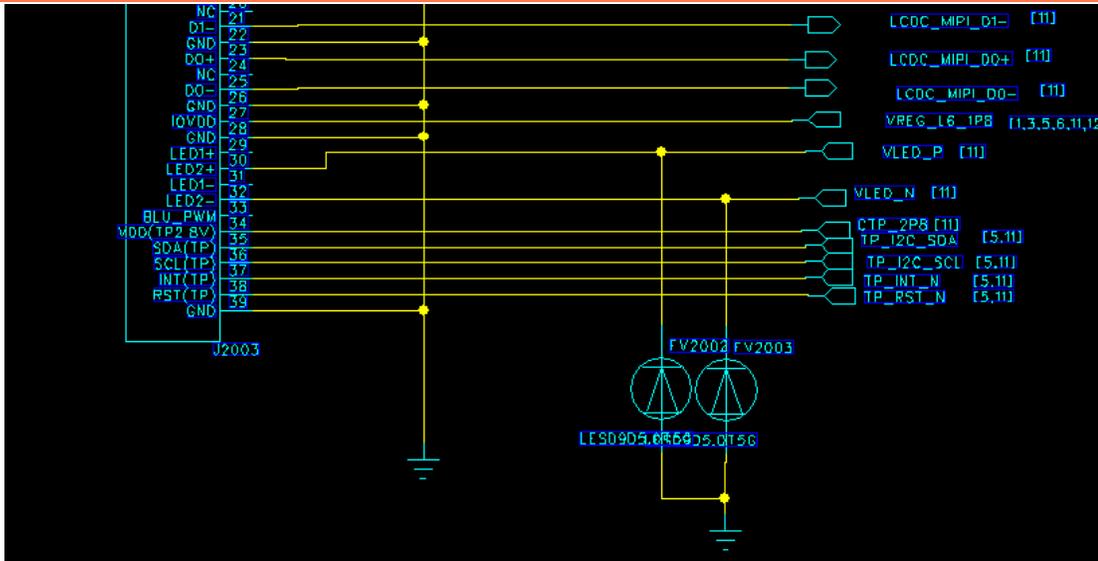
TP circuit

1. The Sensor sensitivity low, slow reaction: software problem;
4. Touch Panel function NG, at present is mainly due to FPC itself partial long cause, the I2C initialization failed;
